Klapmuts Backyard Dwelling Survey

A hazard and vulnerability assessment

June 2016

Disaster Risk Studies Honours Class

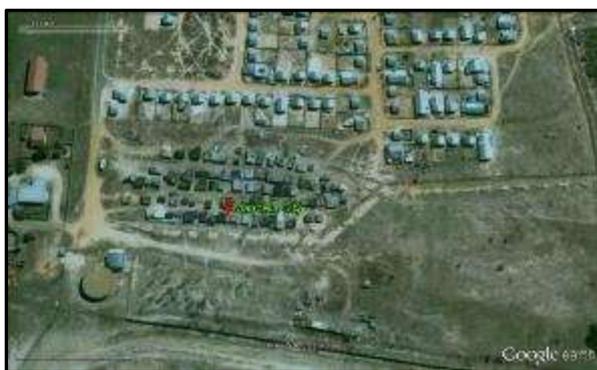
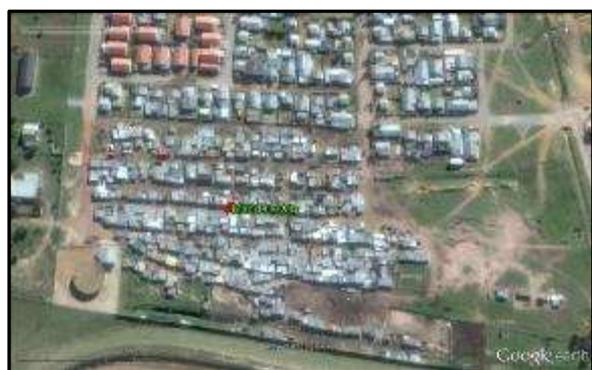
Figure 8 Mandala City - 2005

Figure 9 Mandala City 2015

Sometime in the early 1990s the Mandela City informal settlement was established. From a sprinkling of shacks, the population of the settlement has grown dramatically over the last decade, as evidenced by historical Google Earth satellite imagery in Figures 8 and 9 below.

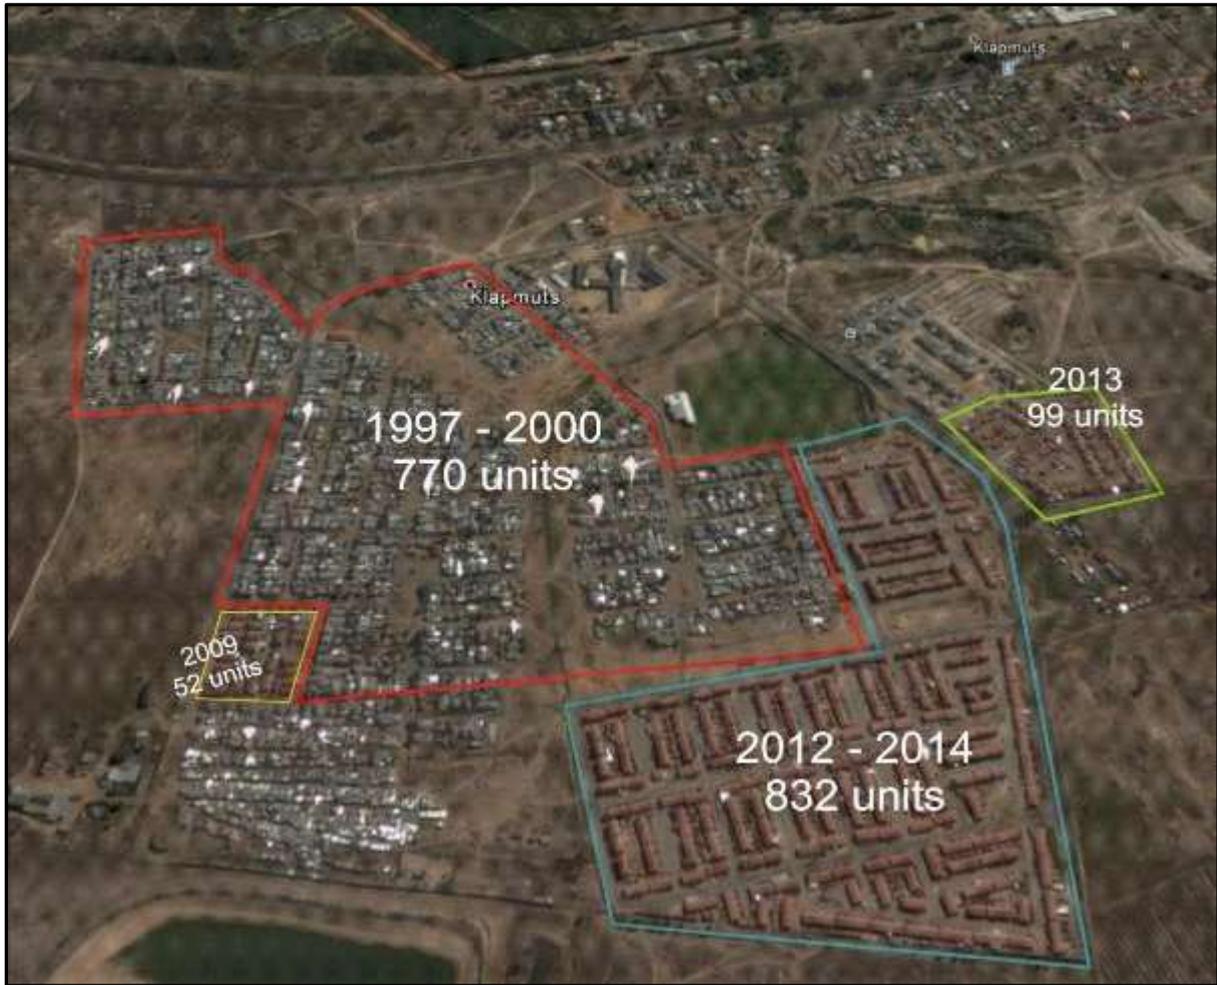
Figure 10 Phases of housing development in Klapmuts

Year	No. houses built	Details
Pre-1997	None	Klapmuts consisted of 5 informal areas and no formal housing
1997-2000	770	First phases of formal housing development: Absorbed a large portion of shack dwellers from La Rochelle and Mandela City
2009	52	Small area adjacent to Mandela City on Eastern boundary
2013	99	Small area below sports field on Western boundary
2012-2014	831	Developed in 3 phases. Included infrastructural services, road infrastructure and construction of top structures.
TOTAL	1752

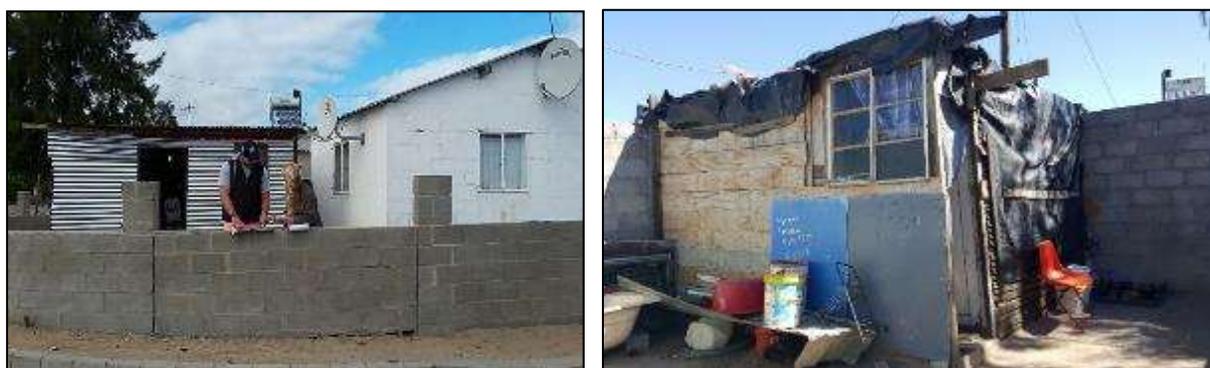
Figure 13 Examples of informal backyard dwellings

The photograph on the left in Figure 13 below shows an example of one of the more robustly built formalised backyard dwellings, built with corrugated iron sheets on a concrete foundation, and insulated against the weather. Water and electricity is supplied from the main house. By contrast the right hand image shows a rudimentary structure, built from salvaged materials, with existing yard walls providing two sides of the dwelling and helping to support the structure, which was not provided with even basic services. The quality of construction differs from one backyard household to another, determined by the socio-economic conditions of the household.

Most backyard dwellings offer inadequate protection from the weather. Respondents frequently complained of poor insulation, suffering excessive heat in summer and bitter cold in winter, when heavy rains also frequently result in leaking roofs and damp walls.

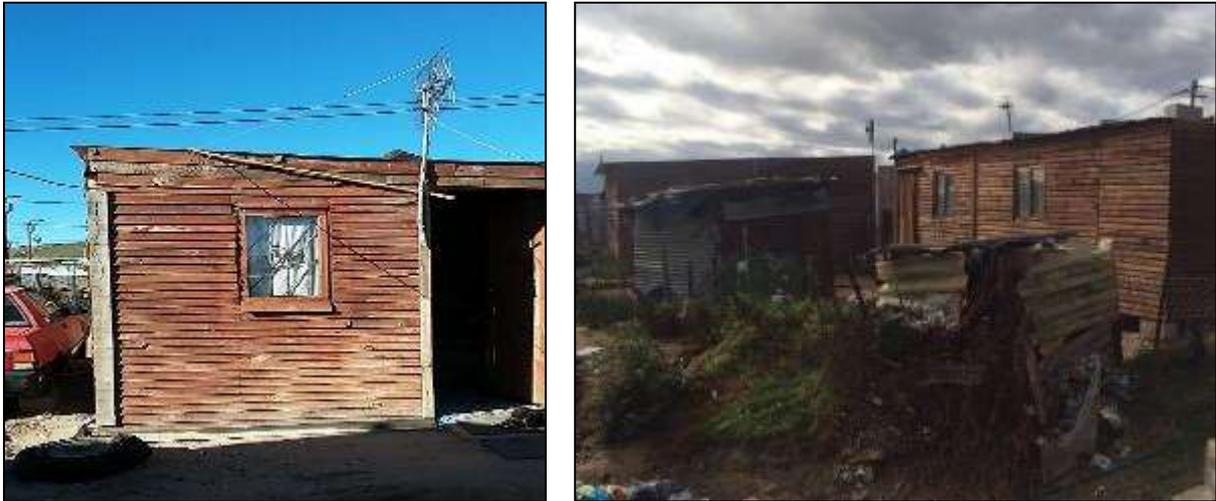
Figure 14 Examples of wooden Wendy house structures

Backyard dwellings also consist of more robustly constructed pre-fabricated Wendy houses (See examples Figure 14 below).

Though seemingly offering a superior form of accommodation to the informal shacks shown in Figure 13 above, wooden dwellings tend to become brittle with age, becoming susceptible to water logging, and leaking, with the planks warping over time. As a method of weatherproofing Wendy houses are often painted with diesel, increasing the potential fire hazard.

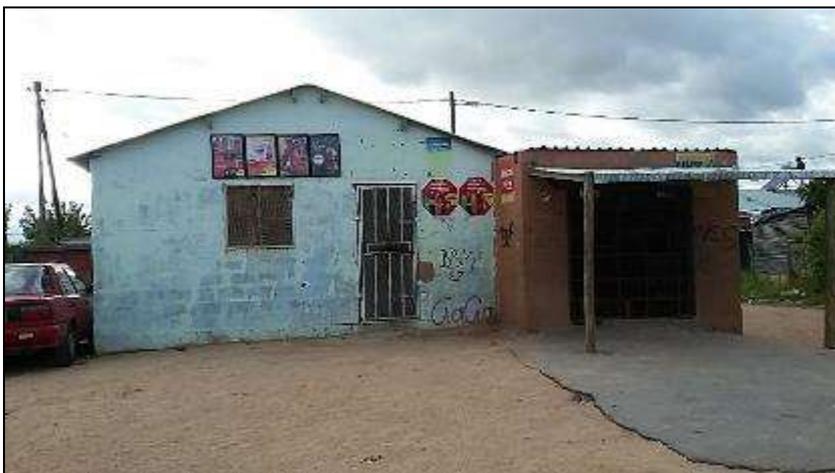
Figure 15 Small business built onto the side of a formal house

While most backyard dwellings in the Klapmuts survey area are built as separate living units (80%), others are not free-standing, either built directly onto the main house (15%) or joined to other backyard dwellings (5%). The addition of extensions and other informal structures can often provide not only living space but also livelihood opportunities and local services. In Figure 15 below a small corner-shop has been built as an extension to a formal house. The owner of the business lives in a backyard dwelling at the back of the house and operates the business from the front.

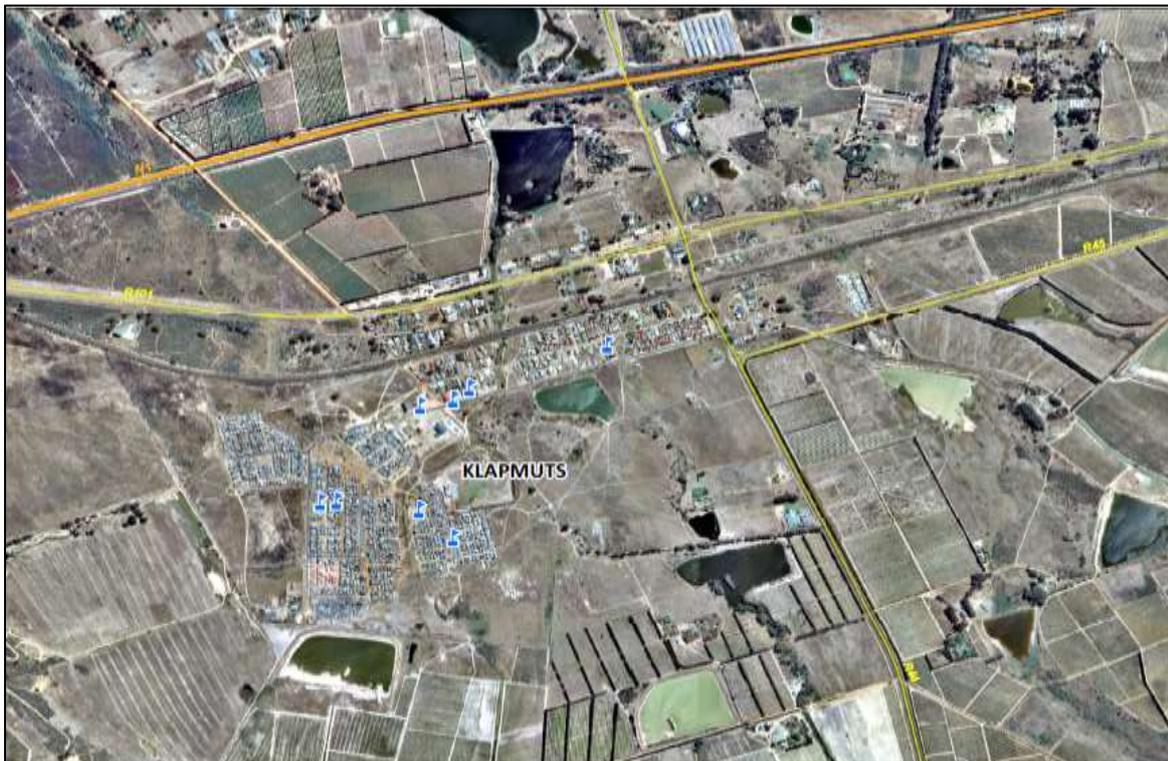
Figure 16 Location of crèches in Klapmuts

Another example of the creative use of backyard business spaces are crèche facilities. In a recent research project undertaken by the Centre for Geographical Analysis at Stellenbosch University, eight crèches in the Klapmuts urban area were identified, several of which were operating from extensions built onto the main house. Figure 16 shows the spatial distribution of these crèche facilities, with four located within the survey area.

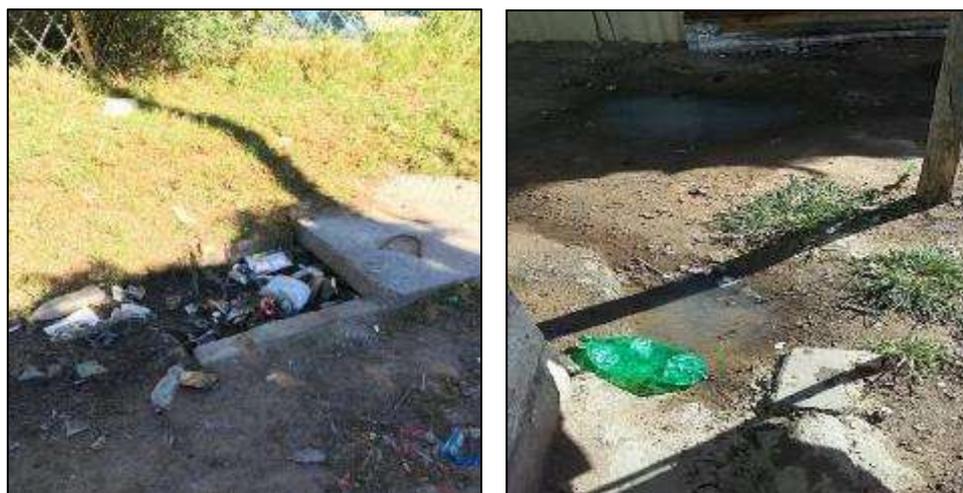
Figure 17 Typical examples of a blocked stormwater drain and backyard ponding

Stormwater drains in the street are frequently used for the disposal of household grey water, even by formal households. In many cases these were found to be blocked with rubbish, preventing effective drainage and resulting in overflows into the street. These typical conditions are illustrated in Figure 17 below. Standing pools of grey water were commonly observed in back yards accommodating backyard dwellings.

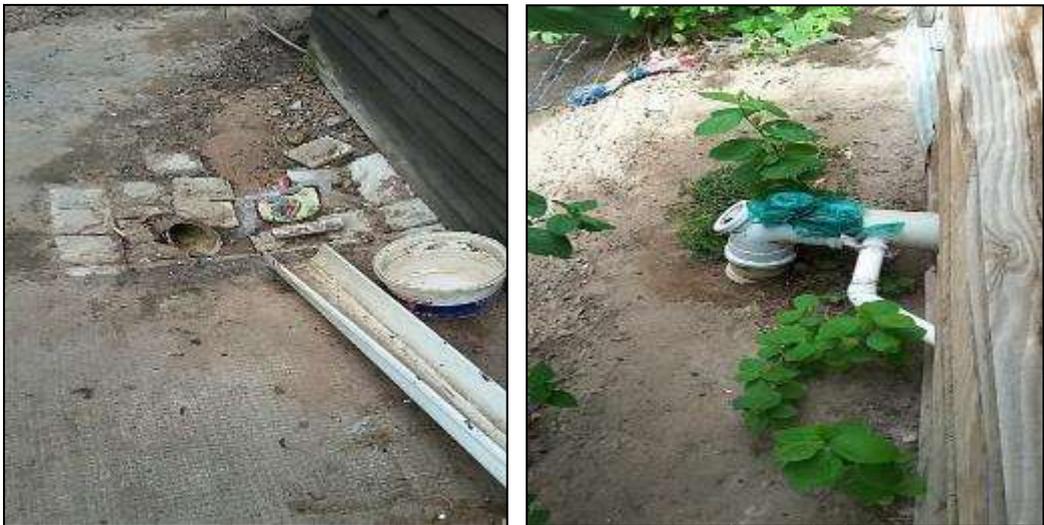
Figure 18 Examples of ponding and rudimentary drainage/sewage system in backyards

Many backyards were found to have no outside drains while where they did exist they were often blocked or overflowing. The survey found that rudimentary drains such as the one pictured on the left in Figure 18 below are also used to dispose of human waste.

Adequate drainage infrastructure is generally lacking in backyards accommodating dwellings. Thus, after heavy rainfall water often collects in the yard and causes localised flooding, resulting in pools of standing water in the yard. In light of service shortfalls, backyarders often organise drainage, wastewater and sewage systems in quite creative ways. In the left-hand image in Figure 18 above, a gutter pipe has been directed towards an informal drain, while in the second image a plastic packet has been used to repair a leaking ad hoc sewerage pipe leading from an informal dwelling.

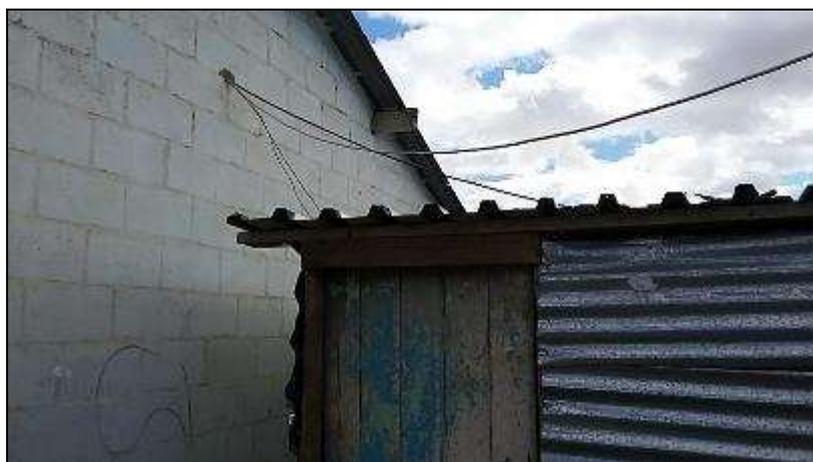
Figure 19 A typical electricity connection from main house to backyard dwelling

Generally a multi-plug is used inside the backyard dwelling to connect a variety of electrical appliances, though the number and type of appliances differs from dwelling to dwelling. Table 15 below illustrates the prevalence of a range of electrical appliances noted in the survey.

Typically most backyard homes had an electrical cooker, most often a 2-plate stove. They generally had lights, a television and a cell phone charger. Few households used heaters and only 10% had computers. Other appliances found less often included microwaves, washing machines, hair dryers and irons, and, occasionally sound systems. This suggests that multi-plugs are frequently overloaded and pose a significant fire threat.

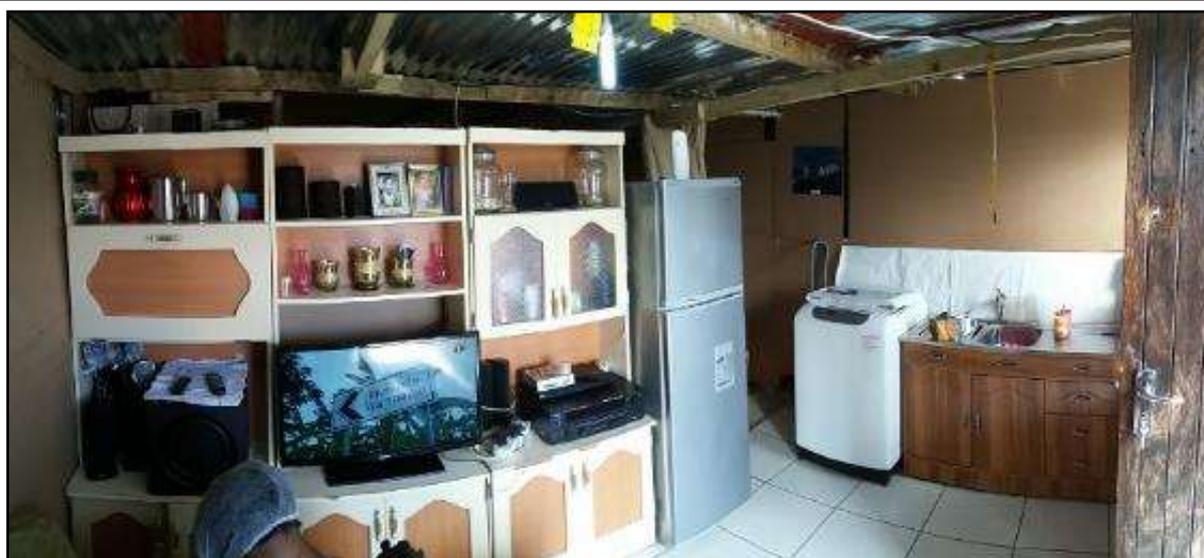
Figure 20 Panoramic view of interior of backyard dwelling showing living and cooking space

The home in Figure 20 above was among a small number recorded with modern facilities and appliances such as tiled flooring, a large refrigerator and washing machine, television, a kitchen sink and a stereo sound system. Cooking was done on a stove with an oven, located out of sight behind the fridge.

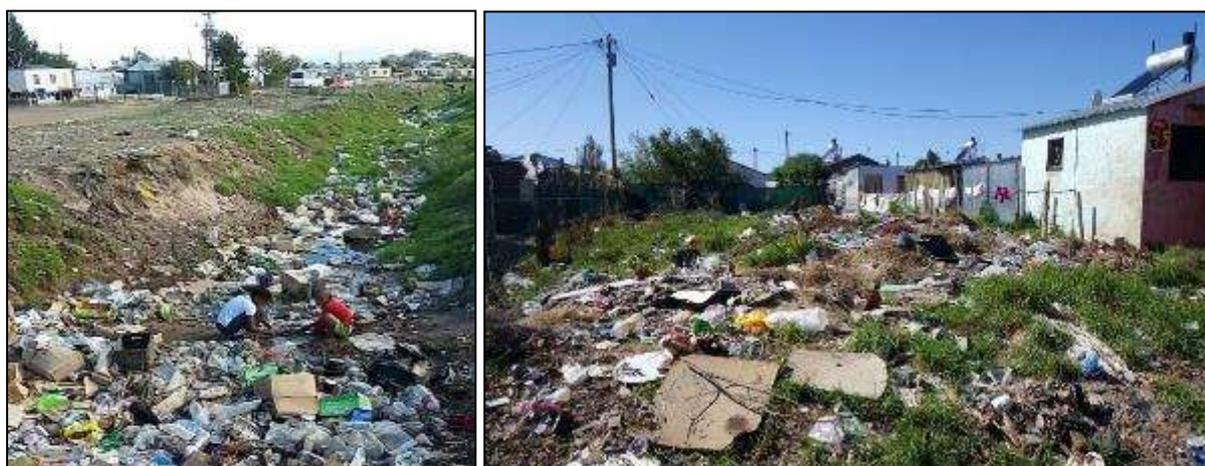
Figure 21 Rubbish collecting in drainage ditch and dumped on open plot

Stormwater drainage channels are generally clogged with litter (See left-hand image in Figure 21 below). The indiscriminate dumping of waste thus also poses both a flood and serious health risk. In Figure 21 below, children are seen playing in the bottom of a drainage ditch being used as a rubbish dump.

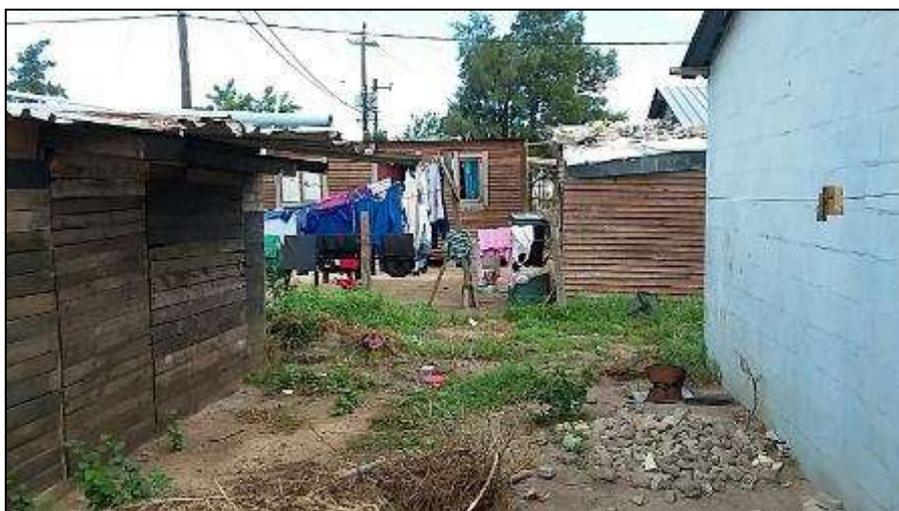
Figure 22 Informal backyard dwelling plot layout

People adapt space in the backyard in order to meet their needs. Backyard dwelling neighbours also often help each other so that layout often follows function, such as shared play spaces for children or communal washing lines as shown in Figure 22 below.

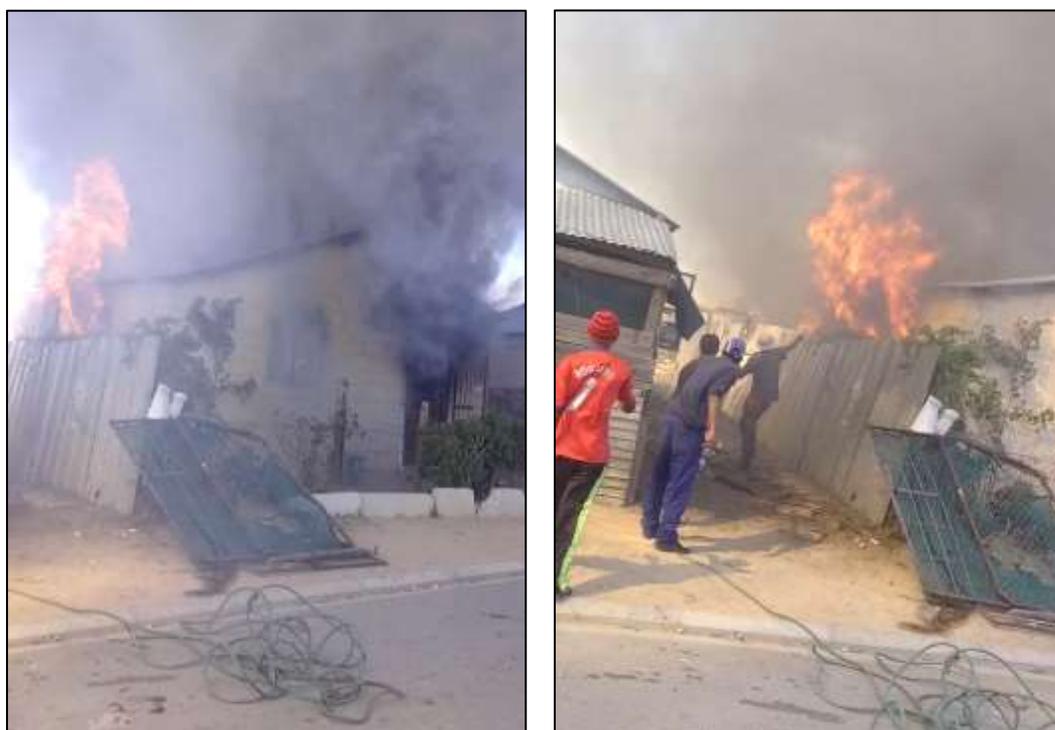
Figure 23 Klapmuts May 2016 fire event

Ability to fight fire is also constrained by limited access to water supply, as illustrated in Figure 23, where someone can be seen trying to extinguish a flaming fire with a simple garden hose. The images below (captured by students while undertaking the survey) demonstrate how a fire that began in the main house, quickly spread to the backyard dwellings and threatened the next door property. The main house and several backyard structures were destroyed in the fire.

The density of backyard accommodation and the storage of building materials and other articles in backyards contributes to fire fuel loads, contributing to fire risk, putting several households in jeopardy in the event of a fire as illustrated in Figure 23 above.

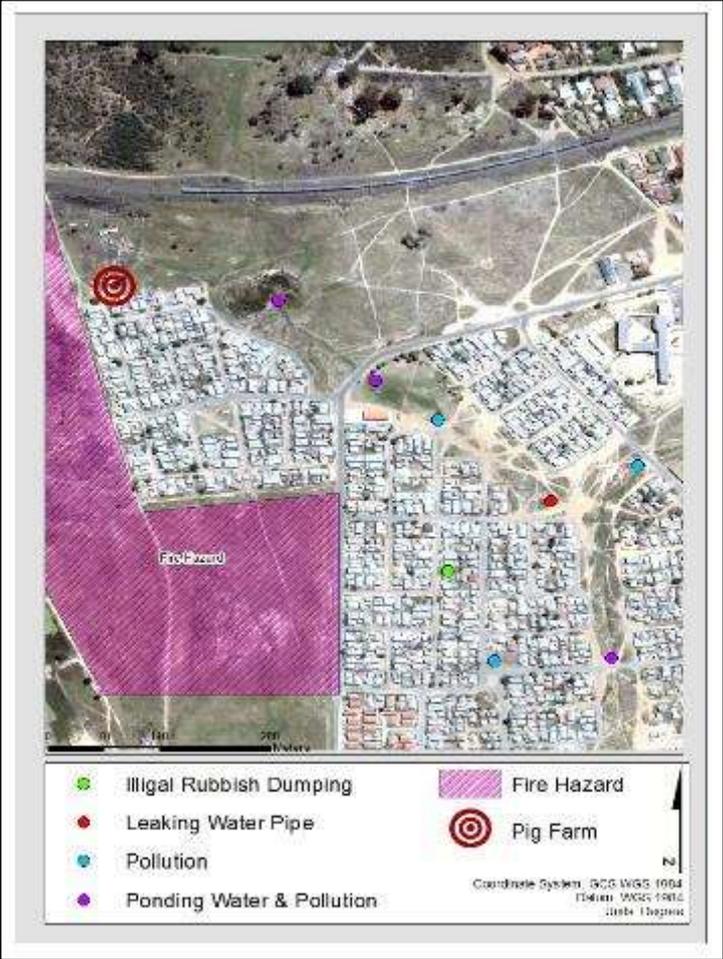
Figure 24 Veld fire risk map of one of the survey areas

In addition to household fires, residents living along the eastern boundary of Klapmuts claimed that they are also exposed to veld fires, particularly in the hot summer months. This area is highlighted in a map in Figure 24 below. The lack of fire-fighting services in the vicinity of Klapmuts is a cause for concern among community members, who related how fire outbreaks very quickly get out of control and exceed local capacity to extinguish.

(Several other hazardous areas have been included in this map of one of the three survey areas. These include an informal pig farm that is posing a health hazard to nearby properties and an associated increase in flies, a large open dumping area, several water and other pollution hot-spots, and the location of a leaking municipal water pipe).

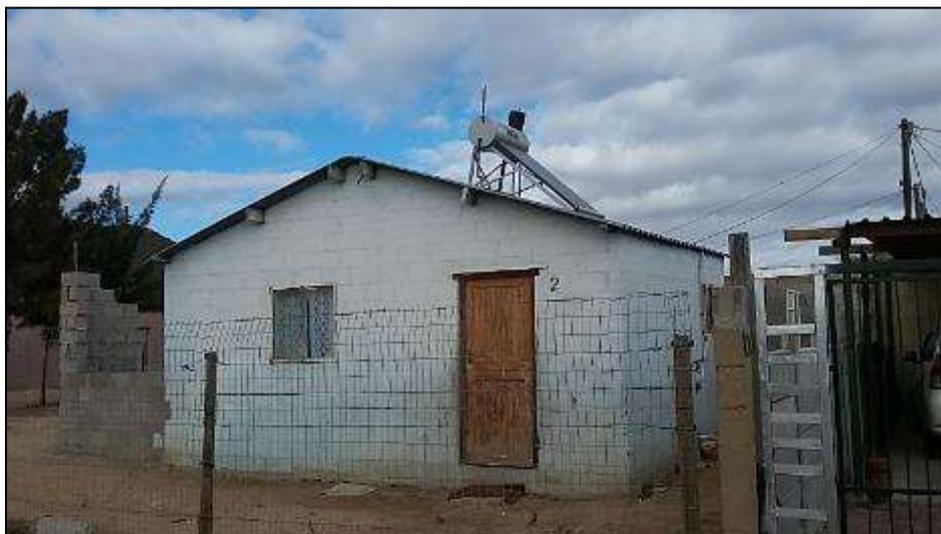
Figure 25 Example of a typical subsidy house in Klapmuts with no guttering

As illustrated in Figure 25 below, most formal houses lack guttering to catch rain water and direct it away from the house. Thus, water simply runs off the roof and into the yard, where it collects. In densely settled yards this leads to ponding of rainfall runoff that cannot drain away and collects in pools of standing water. Such water becomes polluted and contaminated, posing a health threat to all the households accommodated on the property.
